ISSUE NUMBER 6

THE USE OF VERY SMALL UNDERCUT CONCEALED ANCHORS ON GRC/FC BUILDING FACADES

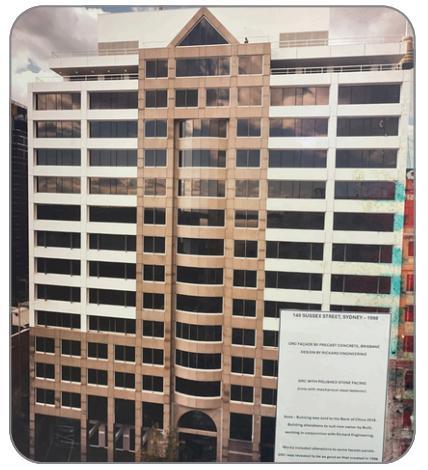
Figure 2. GRC Façade with Face Tiling at 140 Sussex Street, Sydney in 1998

In 1985, I worked for GFRC Texas in the USA and they introduced me to a fixing system that they had developed for the attachment of tiles to the face of their GRC panels. Ten years later, I used the same American fixing system for the attachment of tiles in the late 1990s at 140 Sussex Street, Sydney, see *Figure 2*.

In 2003, the building changed ownership and structural/façade alterations were made to the building. During those alterations I was able to examine the condition of the fixings for the tiles and they were in perfect condition. That detail I subsequently included in the NPCAA Manual for the Design, Manufacture and Installation of GRC in Australia for which I was Technical Editor in 1999, see *Figure 3*.
